A SEM Study Of Copper Corrosion In Bowling Green Supply Lines

A SEM STUDY OF COPPER CORROSION IN BOWLING GREEN SUPPLY LINES

A Thesis
Presented to
The Faculty of the Department of Chemistry
Western Kentucky University
Bowling Green, Kentucky

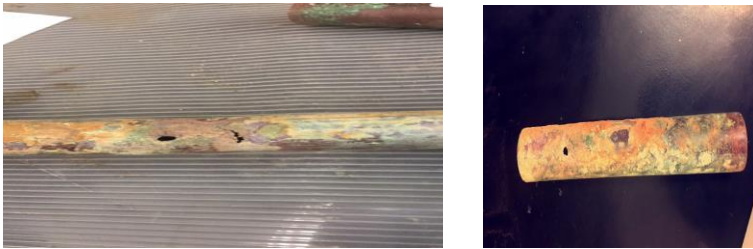
Recently, corrosion of water pipes in Bowling Green, Kentucky has sharply increased. While age was the most common factor initially considered, most of these recent breaks have been in copper pipes less than 20 years old. Moreover, these pipes have corroded from the outside, rather than the inside. These breaks have occurred in copper pipes within a few feet of a curb, under the roadway, leading to speculation as to the factors leading to the breaks, such as the bedding materials (limestone rocks and the constant vibrations from the roadway from the movement of traffic. Figure 4 shows the pipes were corroded from the outside. The original pipe retained most of its thickness and native material.

Figure 4: Corroded water pipe sample from Bowling Green, KY

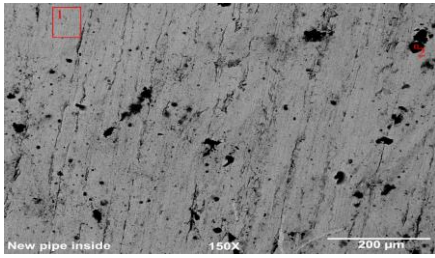
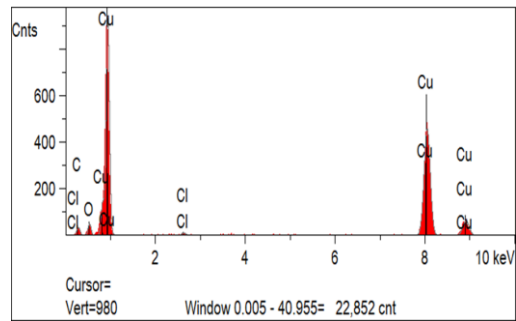
Figure 7 shows the SEM images of the inside and outside area of a new, uncorroded pipe. The SEM images of the new pipe inside area (Figure 7) indicate the surface is clean and smooth with only a very small amount of “islands” of impurities. On the smooth area, the data shows the surface is predominantly copper as expected [Cu (41.138%), Cl (0.369%), C (46.636%) and O (11.857%)] with slight impurities. Analysis of one of the “islands” shows Cu (7.125%), C (76.941%), O (14.865%), Si (0.108%), P (0.052%), S (0.207%), Cl (0.264%), K (0.276%) Ca (0.046%) and Fe (0.117%). SEM images from the same pipe, but on the outside (Figure 8) show a surface that is still relatively clean, but with a slight increase in impurities. Four spots were selected for elemental analysis – two from clean areas and two from impurities. The clean spots indicated predominantly copper with a few trace elements such as Na, Mg, Al, Si, Cl, K and Ca. The impurity areas, which are likely to be copper oxide, had higher levels of trace elements. There are more impurities on the outside and are likely to include Al_2O_3 , SiO_2 and CaCO_3 , which were not observed on the inside area. The brown boxes on the SEM images show the areas that were analyzed.

Atomic Percentage	Spot 1	Spot 2
C	46.636	76.941
O	11.857	14.865
Cl	0.369	0.264
Cu	41.138	7.125
Si	-	0.108
P	-	0.052
S	-	0.207
K	-	0.276
Ca	-	0.046
Fe	-	0.117
Total	100	100

Figure 8: SEM image and analysis of the inside of a new copper pipe.

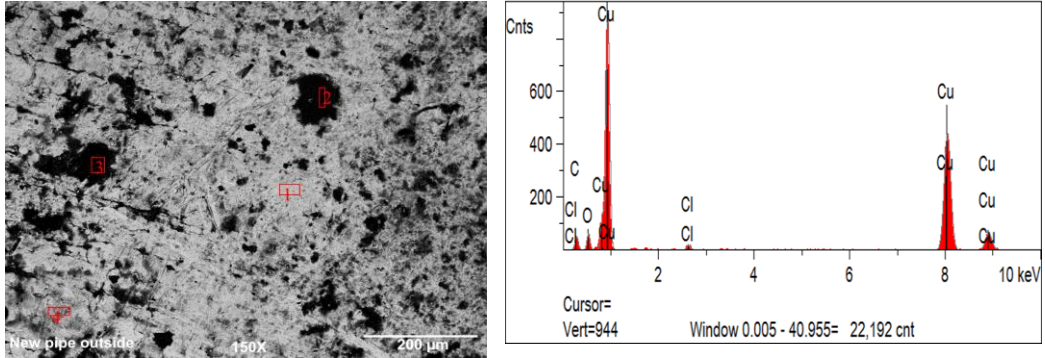
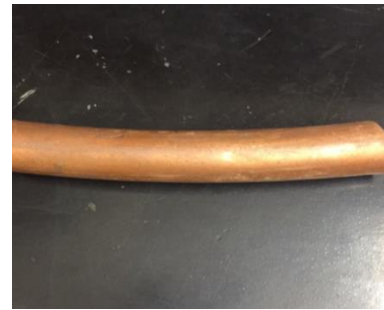
Atomic Percentage	Spot 1	Spot 2	Spot 3	Spot 4
C	52.612	21.712	56.013	55.500
O	13.294	41.216	31.710	21.032
Cl	0.489	-	0.475	0.808
Cu	33.605	4.682	0.577	19.737
Al	-	7.425	0.678	0.761
Si	-	9.025	1.991	0.919
K	-	0.636	0.375	0.126
Ca	-	0.292	4.447	0.221
Ti	-	1.565	-	-
Fe	-	1.337	0.450	-
Na	-	-	0.481	0.817
S	-	-	0.349	-
Mg	-	-	0.577	0.079
Total	100	100	100	100

Figure 9: SEM image and analysis of the outside of a new copper pipe

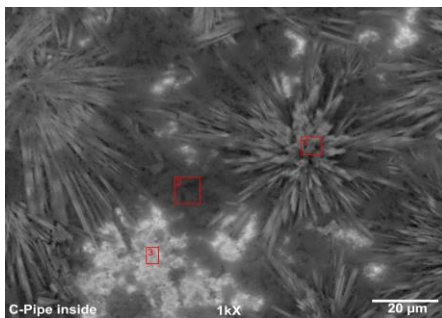
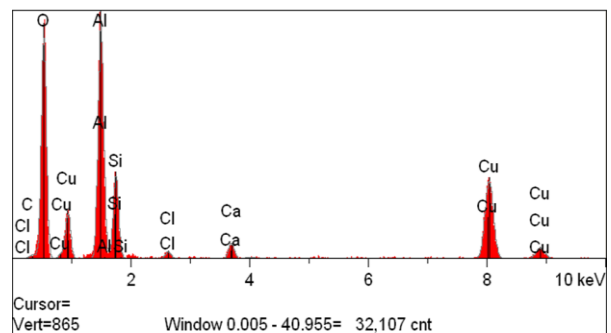
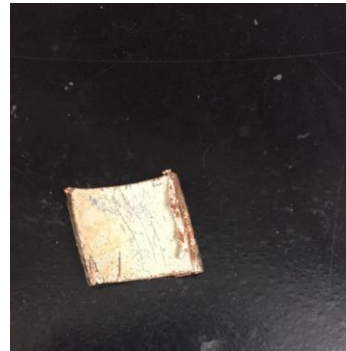
Figure 9 shows the SEM images of the inside area of corroded pipe C. The SEM images show flower-like growths which appear on the surface. Compositions were analyzed for three areas. Spot 1 is on the flower-like area, while spots 2 and 3 were taken on the smooth area. Spot 1 contains Cu (17.00%), Al (13.54%), Si (4.40%), Ca (0.55%) and O (64.51%). Spot 2, which is darker than spot 3, contains Cu (10.72%), Al (19.06%), Si (6.53%), Ca (0.67%), Cl (0.35%) and O (62.67%). Spot 3 contains Cu (27.57%), C (7.93%), O (48.34%), Si (3.87%) and Al (12.29%). From the data shown above, it is most likely that the flower-like material is CuO while spot 2 is where CuO is just starting to grow. Figure 10 is from the outside of corroded pipe C and shows the presence of copper minerals such as malachite and azurite or to other common minerals such as goethite, and calcite.

Atomic Percentage	Spot 1	Spot 2	Spot 3
C	-	-	7.93
O	64.51	62.67	48.34
Cl	-	0.35	
Cu	17.00	10.72	27.57
Al	13.54	19.06	12.29
Si	4.40	6.53	3.87
K	-	-	-
Ca	0.55	0.67	4.447
Total	100	100	100

Figure 10: SEM image and analysis of the inside of pipe C

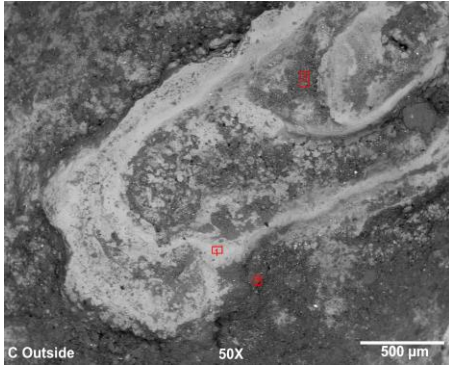
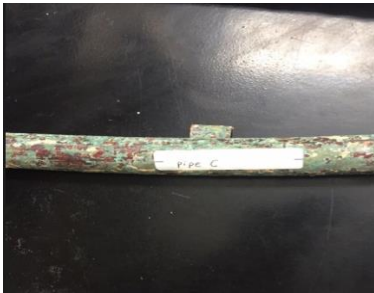
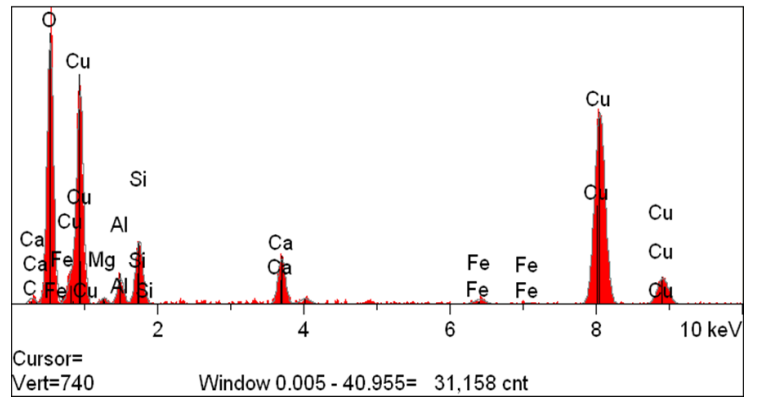
Atomic Percentage	Spot 1	Spot 2	Spot 3
C	7.76	8.52	-
O	62.11	70.78	58.29
Cl	-	-	-
Cu	21.04	4.682	18.82
Al	2.12	2.10	3.77
Si	4.17	4.26	10.24
K	-	0.17	0.50
Ca	1.59	9.56	5.87
Ti	-	-	-
Fe	0.36	0.39	-
Na	-	-	-
S	-	-	-
Mg	0.86	1.35	2.52
Total	100	100	100

Figure 11: SEM image and analysis of the outside of pipe C

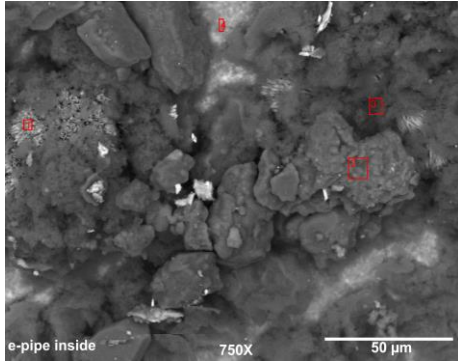
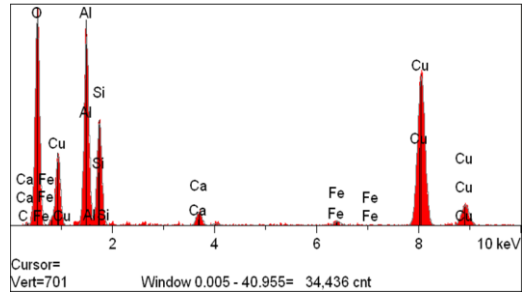
Figure 11 shows a SEM image of the inside area of corroded pipe E. From the SEM image of the inside area, data were taken on four spots. Spot 1 is on the area with a lot of needle-like material. Spot 2 is the place with more small particles. Spot 3 is the darkest area, while spot 4 is the brightest. Spot 1 data are Cu (18.60%), Al (15.61%), Si (7.61%), Ca (0.62%), C (1.90%), Fe (0.29%) and O (55.33%). Spot 2 data are Cu (3.55%), Al (11.18%), Si (17.77%), Ca (0.37%), Fe (1.33%), Mg (0.61%), K (0.35%), Cl (0.09%) and O (65.04%). Spot 3 data are Cu (18.82%), O (50.79%), Al (18.36%), Si (10.88%), Ca (0.62%), Cl (0.16) and Fe (0.36) while Spot 4 showed Cu (15.35%), O (58.10%), Al (16.22%), Si (9.41%), Ca (0.62%) and Cl (0.30%). Spot 2 contains much more Si than the other areas, which means the small particles are likely SiO₂. Spot 3 and Spot 4 are similar. From the SEM image of the outside area (Figure 12), there are not big blocks like what is shown on inside surface. Compared to the inside area, the outside one is much smoother with more small particles on the surface. In the smooth area, the analysis shows Cu (50.13%), O (43.48%), Al (1.23%), Si (3.07%) and Ca (2.09%), while the small particles contain Cu (19.53%), Al (1.20%), Si (3.76%), Ca (4.77%), Fe (0.29%), Mg (1.10%), K (0.11%), C (22.74%) and O (46.51%). In comparison to the uncorroded pipe outside area, there are more impurities in the small particles on the surface and the amount of C is also larger.

Atomic Percentage	Spot 1	Spot 2	Spot 3
C	7.76	1.90	3.55
O	50.79	55.33	65.04
Cl	0.16	-	0.09
Cu	18.82	18.60	18.82
Al	18.36	15.61	11.18
Si	10.88	7.64	17.77
K	-	-	0.35
Ca	0.62	0.62	0.37
Ti	-	-	-
Fe	0.36	0.29	1.03
Na	-	-	-
S	-	-	-
Mg	-	-	0.61
Total	100	100	100

Figure 12: SEM image and analysis of the inside of pipe E inside

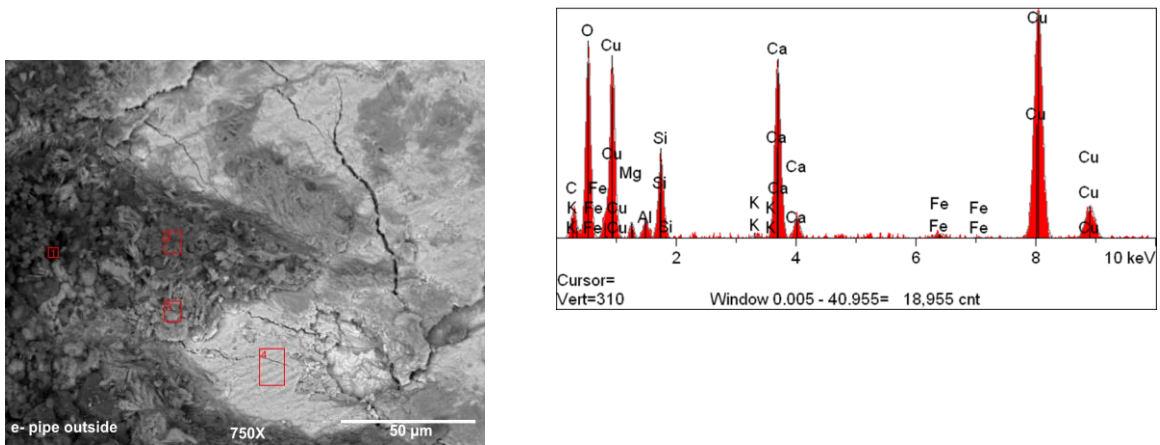
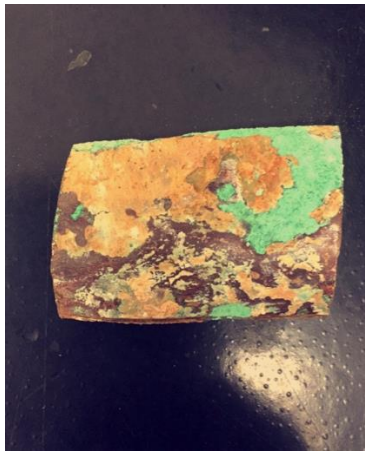
Atomic Percentage	Spot 1	Spot 2	Spot 3	Spot 4
C	22.74	1.90	3.55	
O	46.51	55.33	65.04	
Cl	0.16	-	0.09	
Cu	19.53	18.60	18.82	
Al	1.20	15.61	11.18	
Si	3.76	7.64	17.77	
K	0.11	-	0.35	
Ca	4.77	0.62	0.37	
Ti	-	-	-	
Fe	0.29	0.29	1.03	
Na	-	-	-	
S	-	-	-	
Mg	1.10	-	0.61	
Total	100	100	100

Figure 13: SEM image and analysis of pipe E outside

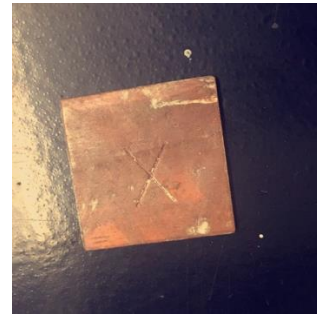
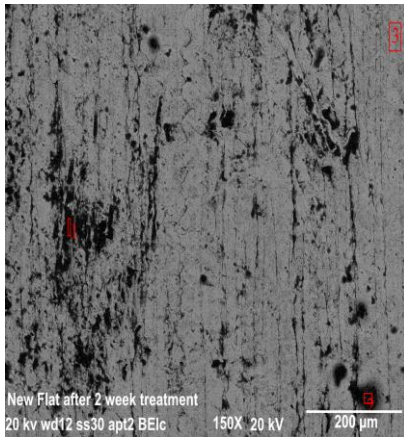
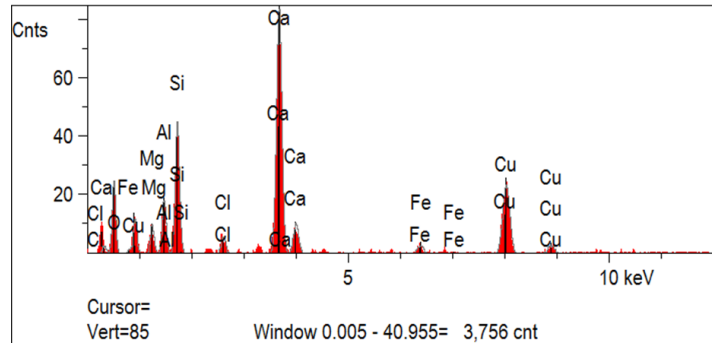
Figure 15 shows the SEM image of uncorroded pipe with pipe in contact with water, limestone and vibrations was compared after two weeks of vibrations. After two weeks, the pipe showed longer sections of dark spots forming line-like structures. This could be due to the scraping of limestone on the pipe under the conditions of shaking.

The SEM analysis showed the percentage of calcium on the surface as did oxygen, showing that calcium carbonate is depositing on the surface. A trace amount of iron deposits were also detected. The iron can be from either the water or limestone.

Atomic Percentage	Spot 1	Spot 2
O	51.882	52.084
Mg	3.530	1.936
Al	4.891	0.052
Si	9.832	0.558
Cl	1.066	0.062
Ca	15.076	10.872
Fe	1.035	0.263
Cu	12.688	5.068
O	-	29.106
Total	100	100

Figure 16: SEM image and analysis of new pipe and limestone after two weeks

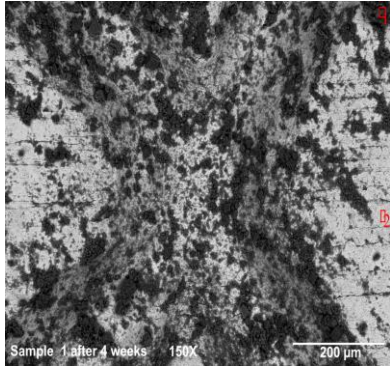
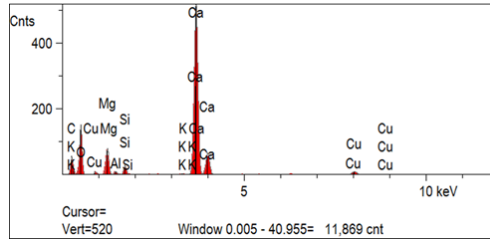
Figure 16 shows the SEM image of new pipe and limestone after four weeks. From the SEM image, we can see a lot of black particles or spots and a two rod like structures. EDS data were taken on two spots. Spot one is on the area with clear Surface. Spot 2 is the place with more big black particles. The table shows the atomic percentage of the elements present in on the two spots.

Atomic Percentage	Spot 1	Spot 2
C	23.766	25.262
O	58.221	11.075
Mg	3.151	-
Al	0.319	-
Si	0.685	-
K	0.058	-
Ca	12.955	-
Cu	0.846	63.662
Total	100	100

The percetage of oxygen is higher in the 4 weeks interaction than in the 2 weeks interaction. We also see the presence of copper which is from the limestone. The percentage of copper has also decreased in great value. The percentage of oxygen has also increased.

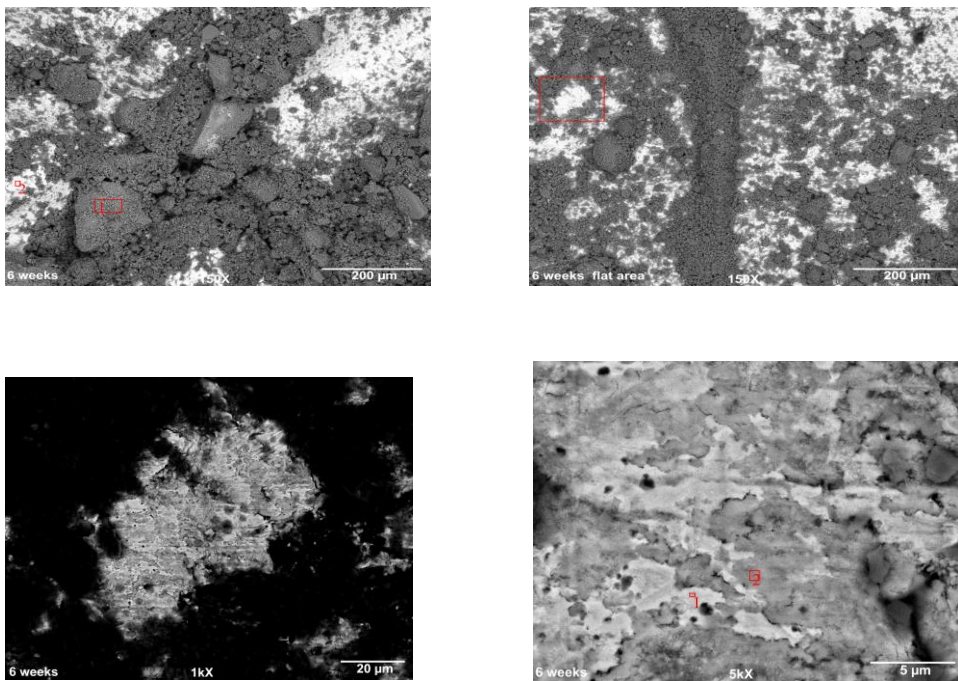
Figure 18 shows the SEM image of flat copper pipes with water, limestone, and vibration after 6 weeks. The SEM images show many more impurities, which contains calcium and oxygen and are probably calcium carbonate deposits from the limestone. Moreover, expanded views of the surface shows substantial pitting, growths of calcium carbonate filling in the pits and growing together. The 5K image show a lot of pitting on the surface because limestone causes damage on the surface.

Figure 19: SEM image of flat copper pipes with water, limestone, and vibration after 6 weeks.

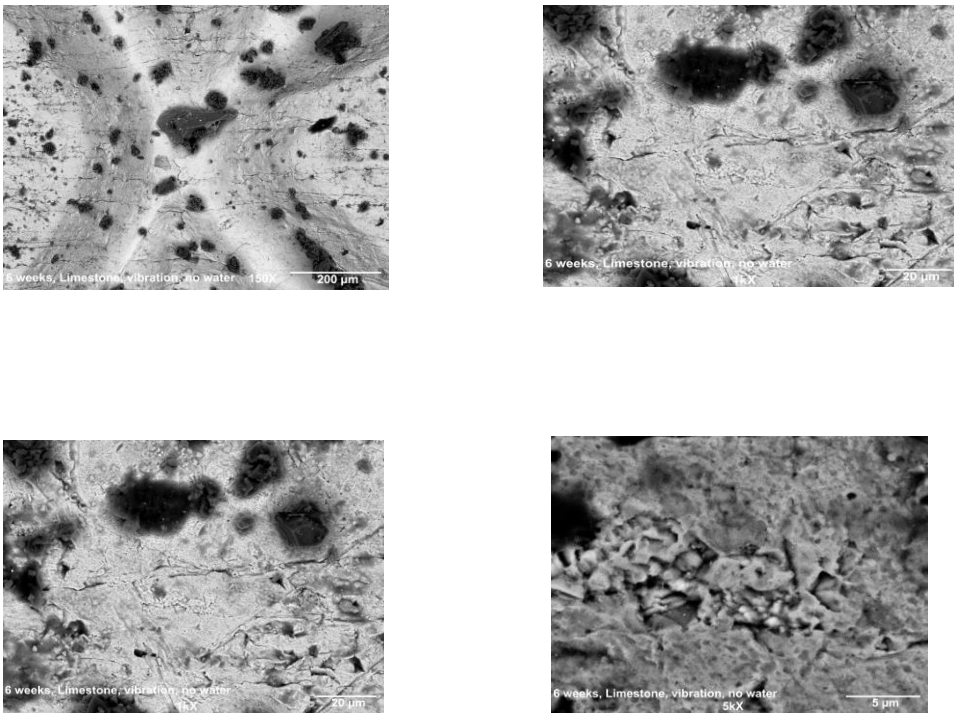
The effect of water is clear. Figure 19 shows SEM image of flat copper pipes with limestone, vibration, and no water after 6 weeks. Little pitting is observed. The X scratch is clean and clear. The dark areas are calcium carbonate but this appears to be mostly dust that settled onto the surface and grooves.

Figure 20: SEM image of flat copper pipe with limestone, vibration, and no water after 6 weeks.

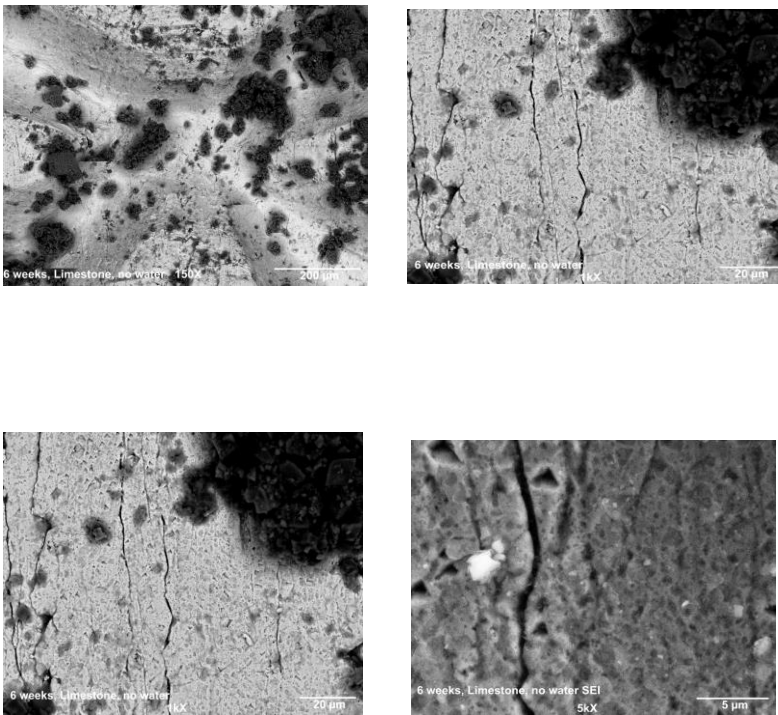
Figure 20 shows the SEM image of flat copper pipe with limestone but with no water and no vibration. From SEM image of X scratches and flat area, we can find it has only slight impurities. The dark areas are calcium carbonate. This sample indicated what dust from the limestone on the surface would be, although even dust creates a slightly impacted surface

Figure 21: SEM image of flat copper pipe with limestone, no vibration, and no water after 6 weeks.

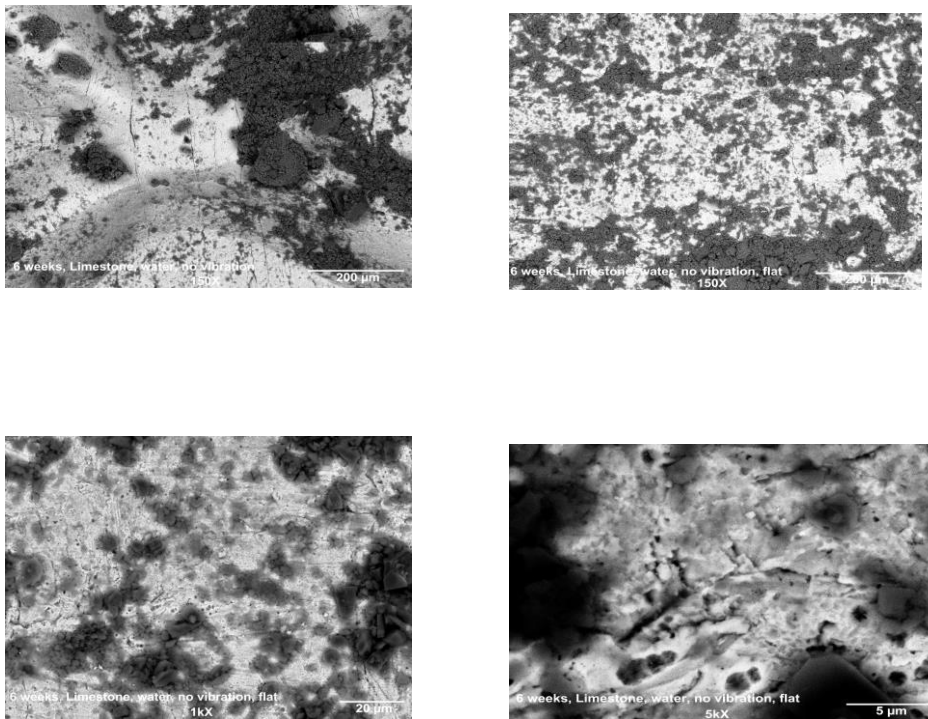
Figure 21 shows SEM image of flat copper pipe with limestone and water but no vibration. From the image of the X scratch and the flat area, we see increased pitting and calcium carbonate deposits. Even without vibration, the presence of water allows surface reactions to take place with the limestone. However, the vibrational motion clearly sharply enhances the deposition of calcium carbonate and changes in surface morphology.

Figure 22: SEM image of flat copper pipe with limestone, water, and no vibration, after 6 weeks.
