"The House That's Sinking in the Middle?"

Chris Antonsen and Carolyn Helm

Vernacular Architecture

Western Kentucky University

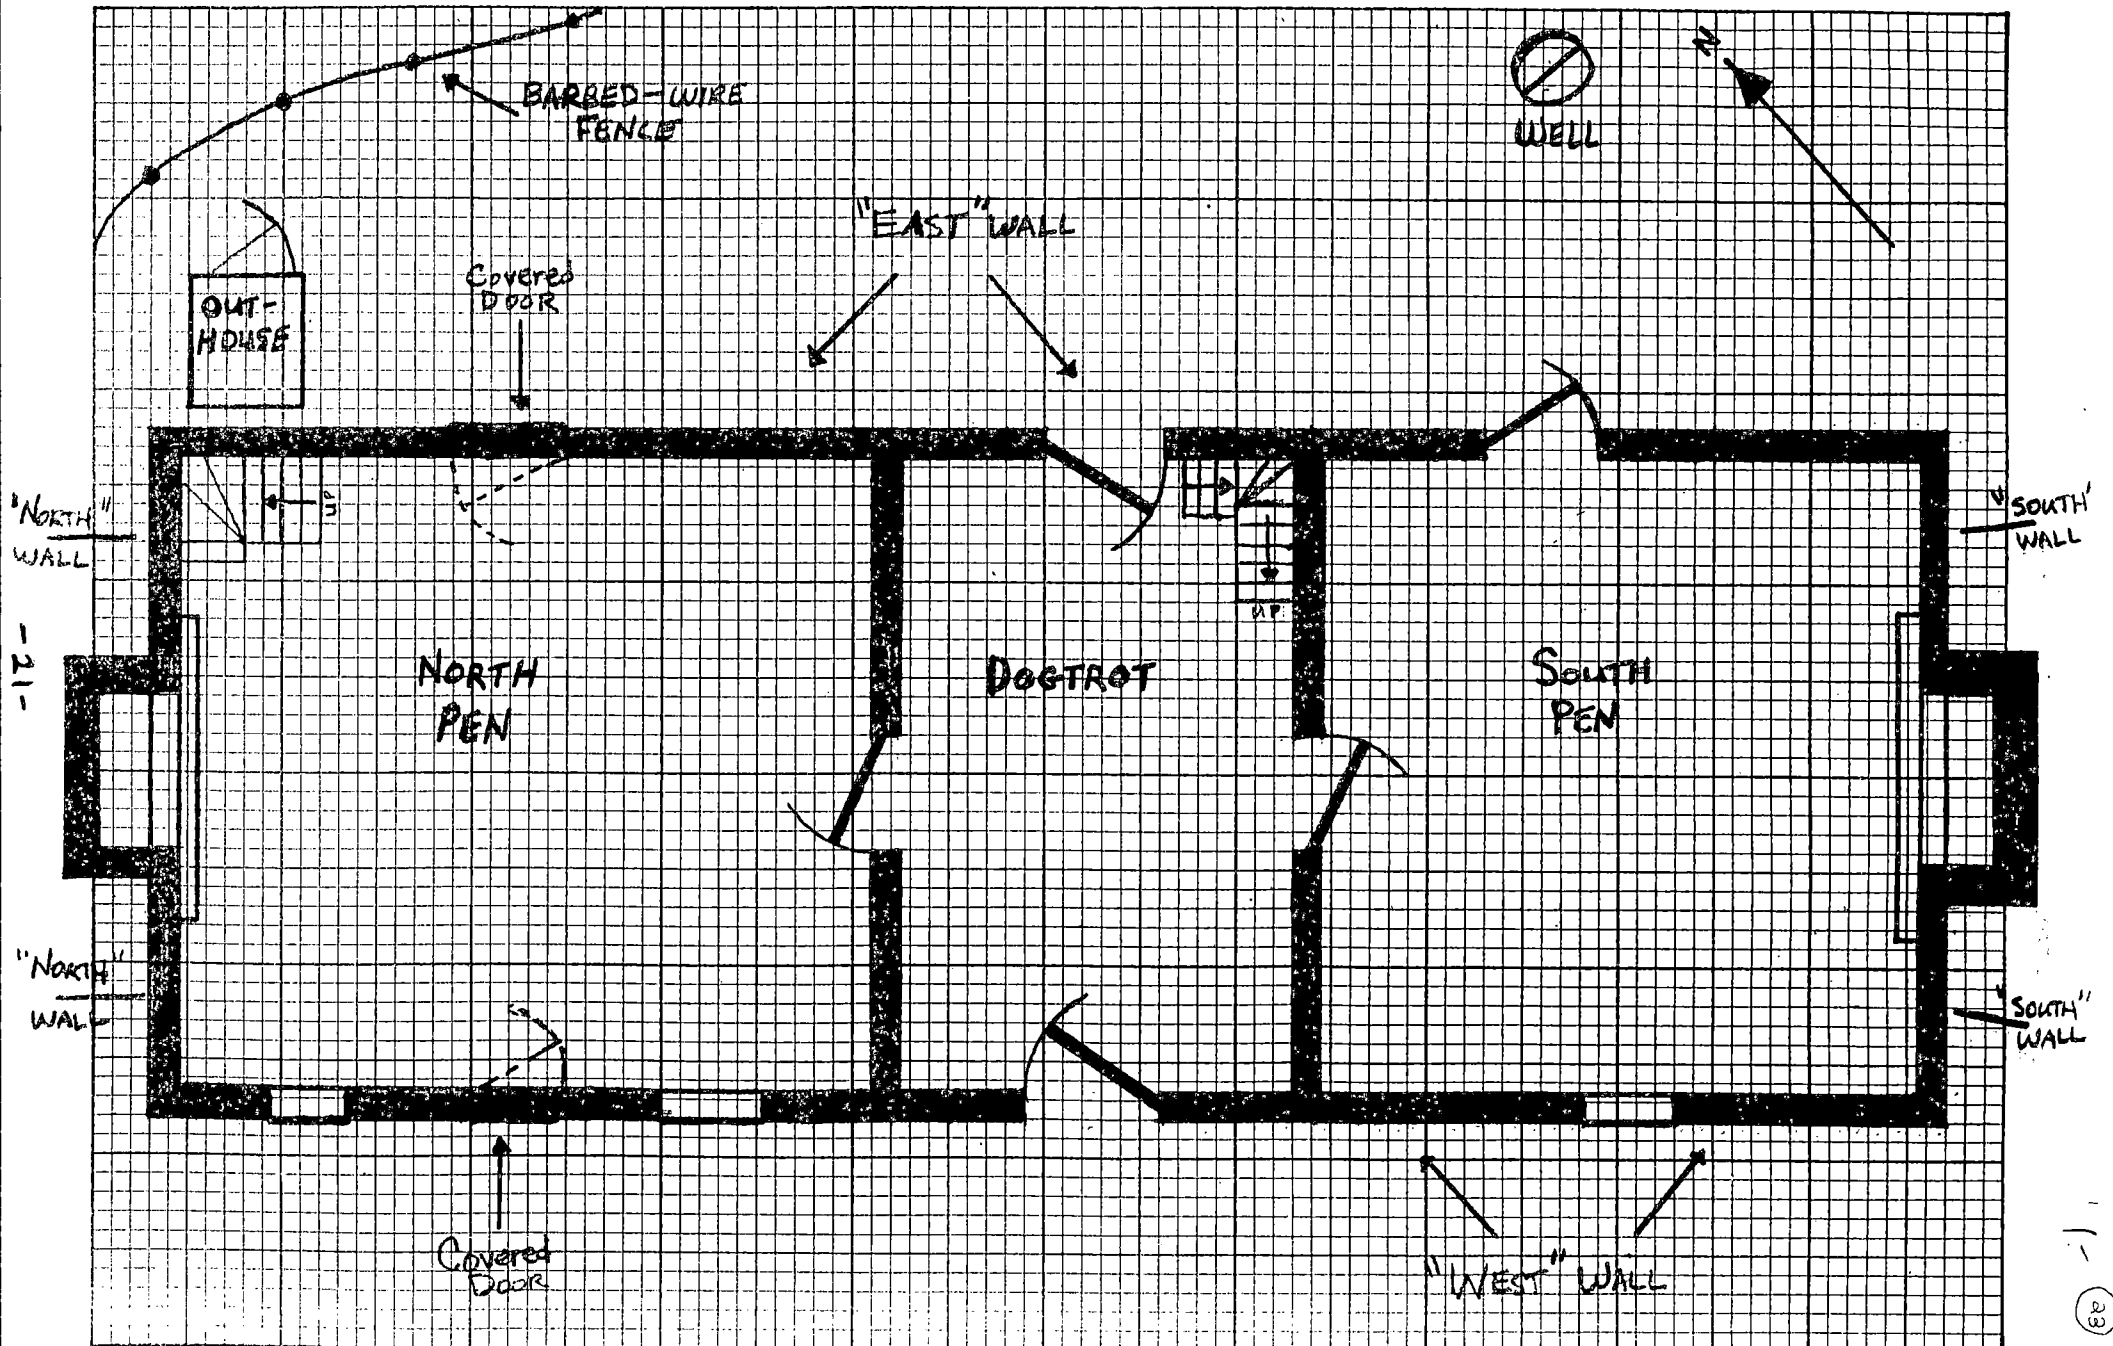
Appendix I  
Floorplan of the House

— GROUND FLOOR: TWO-LEVEL LOG DOGTROT SIMON COUNTY, KENTUCKY —
