Cars and Karst: Investigating the National Corvette Museum Sinkhole

CARS AND KARST: INVESTIGATING THE NATIONAL CORVETTE MUSEUM SINKHOLE

Abstract

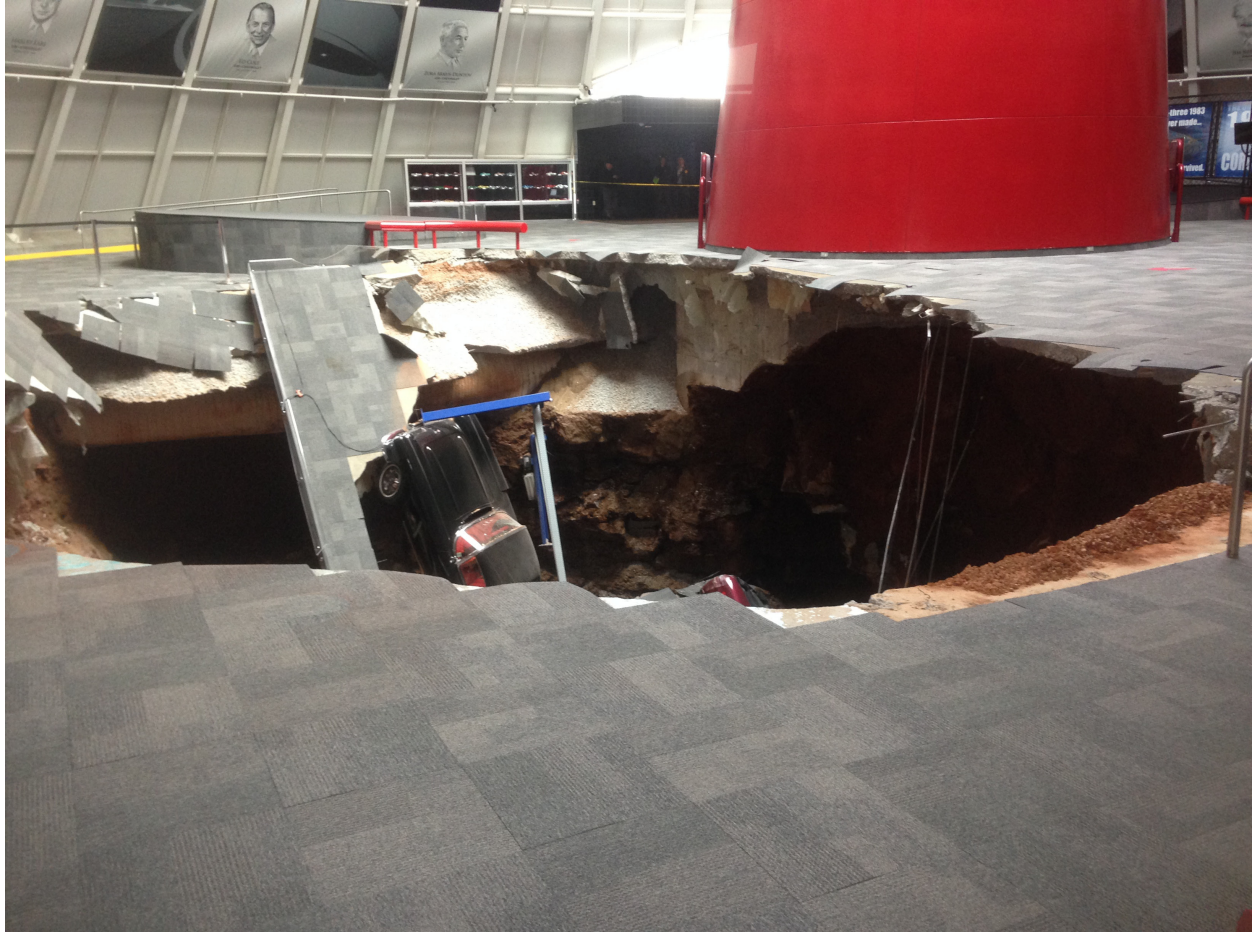
Figure 1. Initial sinkhole collapse: The original collapse on the day it occurred at the National Corvette Museum in Bowling Green, Kentucky.

On February 12th, 2014, a sinkhole occurred at the National Corvette Museum in Bowling Green, Warren County, Kentucky. The collapse happened inside part of the building known as the Skydome, which is a large circular structure connected to the main building where rare Corvettes are displayed (Figure 1). On the day of

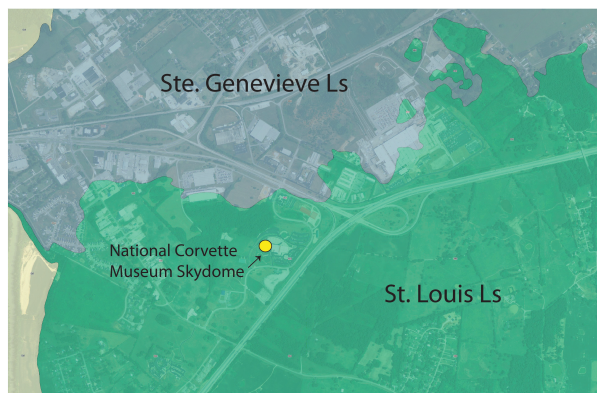
Figure 2. Local Geology at the Skydome: The Skydome is located near the contact between the Ste. Genevieve and St. Louis limestones on the Pennyroyal sinkhole plain. Data from the KGS Map Information Service.

The National Corvette Museum is located in the Pennyroyal Plateau, which encompasses the Pennyroyal sinkhole plain of south-central Kentucky. The Skydome structure sits atop the contact between the Ste. Genevieve and St. Louis limestones (Figure 2), both of which are Mississippian aged formations that comprise a large majority of the cave-forming bedrock in the region, including hosting many of Mammoth Cave's passages (Palmer 1981, Palmer 2007). These formations are often thinly bedded at the contact and dip gently toward the north. The Corydon ball chert layer is present and located at the contact between the Ste. Genevieve and St. Louis limestones. Sinkholes, both shallow and deep, are prominent features throughout the landscape and vary in depth based on the rock unit in which they form (Howard 1968). Adjacent to the Skydome to its south and northwest are large subsidence sinkholes. The southern sinkhole holds water throughout the year due to compacted clays or an impermeable chert layer at its bottom, or a combination of both.

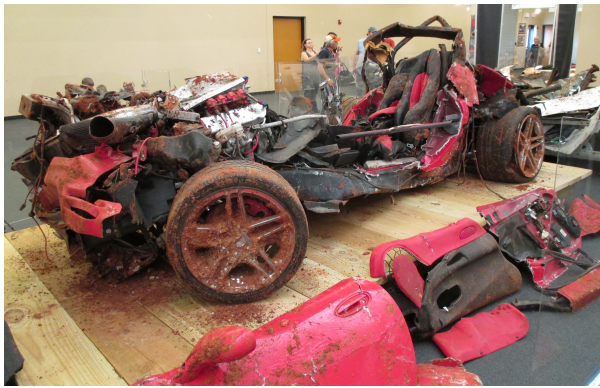
Figure 3. Remains of a Corvette: After extraction from the sinkhole, some Corvettes were repaired, while others were damaged beyond repair. Three were fixed by General Motors and private funds, and the others are on display at the Museum.

booms and lift them from the sinkhole. All eight were recovered with varying amounts of damage, with some completely destroyed from the large breakdown that fell into the hole on top of them (Figure 3).

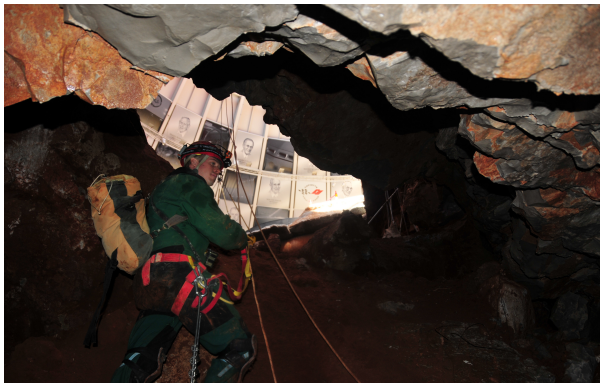
Figure 4. Entrance to southern cave passage: Brian Ham of EnSafe, Inc. stands at the entrance of the southern cave passage. The cantilevered breakout dome can be seen as the sinkhole walls migrate upward.

After retrieval of the Corvettes and stabilization of the hole, a team from WKU and EnSafe explored the sinkhole and discovered additional cave passages (Figure 4). A grade 5 cave survey was undertaken to map the sinkhole and cave passages. This was tied in to the surface engineering survey in order to better determine possible areas of concern and to develop a remediation plan for repairing the Skydome floor and any other structures outside the building as needed.

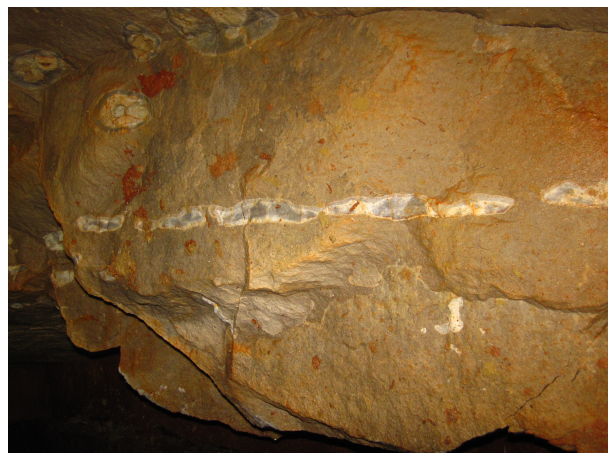
Figure 5. Chert layer: Remnants of a layer of Corydon ball chert, which appears to be cleaved off from where the surrounding limestone has broken away, revealing the impurities that amplified the rock's weakness.

Inside the cave, the debris cone consists mainly of large breakdown and weathered limestone, with some overlying soils. The limestone comprising the cave walls was thinly bedded. The sinkhole is located at the contact between the St. Louis and Ste. Genevieve, where the Corydon ball chert layer (present in the ceiling, Figures 5 and 6) created conditions for instability over the span of the breakdown dome that failed. As the layers of rock collapsed over time, the breakdown dome continued to migrate upward toward the floor of the Skydome and likely was already fairly thin prior to its construction, as this would have been a slow geologic process. Additional wedging from calcite mineral formation between

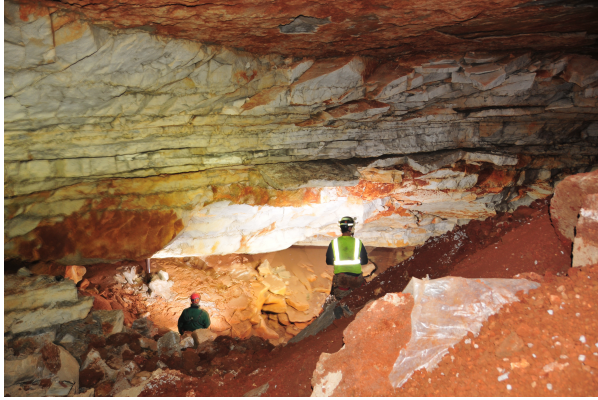
Figure 6. Thinly bedded limestone: The walls of the cave passage in the northern section of cave leading up to the sinkhole entrance. Thinly bedded St. Louis limestone layers are clearly visible.

the limestone beds likely created further weakness in the structure of the rock. There are many stylolites found within the limestone beds as well, along the planes of which additional points of weakness exist. These lateral stylolitic seams can enhance fluid flow and dissolution along their path, where delamination and cracking can occur (Heap *et al.* 2013), as was observed in the cave. Over time, a breakout dome formed and migrated upward, thinning the bedrock support and creating a situation wherein structural failure and the sinkhole collapse was imminent.

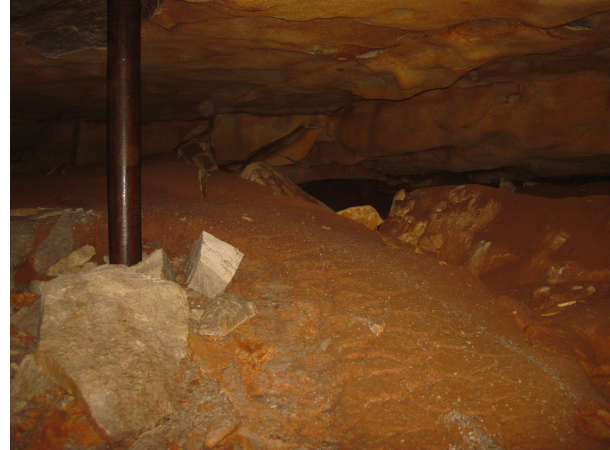
Figure 7. Micropile under the Skydome: A micropile breaching the northern cave passage that was installed to support the Skydome structure before the remediation of the sinkhole was initiated.

Hayward-Baker, Inc. (Nashville, Tennessee) was consulted and a plan was formulated to repair the sinkhole and Skydome using micropiles to support a concrete slab floor (Figure 7). The debris cone was first smoothed flat and a one-foot (0.3 m) thick concrete slab was poured, then a double layer of metal sheet pilings were laid horizontally over it and cut to fit the shape of the sinkhole walls. The sinkhole walls were covered in specific areas with shotcrete to stabilize them further. The sheet pilings served as a base for filling the remainder of the hole to the floor with 4000 tons (3.5 x 10⁶ kg) of manufactured sand to support the concrete floor. The primary purpose of the sheet pilings is to block the manufactured sand from filling the north and south passages. Its function is to provide support to micropile drilling equipment and temporary support for structural concrete slab construction. Holes were cut in the sheet pilings to drill the micropiles down to the bedrock. The micropiles are 7 inches (17 cm) in diameter (Figure 7) and will be placed at an average depth of 141 ft. (43 m), with a range of 130

to 200 ft. (39-55 m) below the floor to reach competent bedrock and will be tied into the concrete slab floor to provide support. The 46 micropiles are installed on a 20 x 25 foot (roughly 6 m) grid under the Skydome; there are 23 existing micropiles in place under the footprint of the building and the spire in the center.
