A SEM Study Of Copper Corrosion In Bowling Green Supply Lines

A SEM STUDY OF COPPER CORROSION IN BOWLING GREEN SUPPLY LINES

A Thesis
Presented to
The Faculty of the Department of Chemistry
Western Kentucky University
Bowling Green, Kentucky

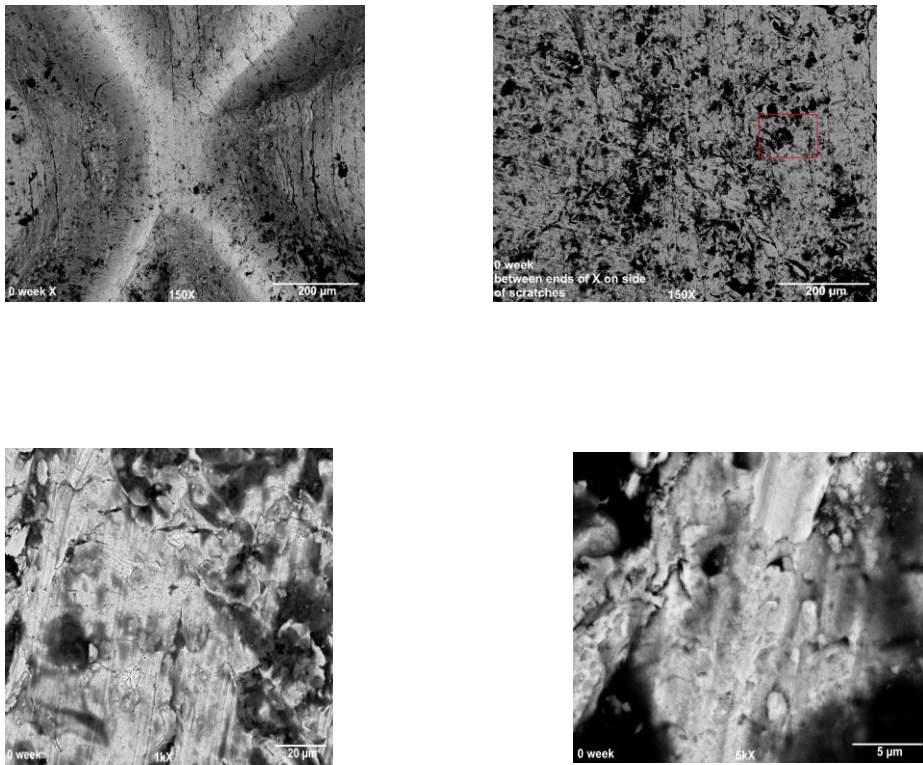
Figure 18: SEM image and analysis of flat clean copper pipe

Figure 17 shows the SEM image of flat clean copper pipe. The SEM image of the X scratch is very clean. SEM images between the two ends of the X scratch were also analyzed. While there are both spot and bright spots, the surface is generally very clean and smooth and contains mostly copper while the spots are probably mostly copper oxide.

Figure 18 shows the SEM image of flat copper pipes with water, limestone, and vibration after 6 weeks. The SEM images show many more impurities, which contains calcium and oxygen and are probably calcium carbonate deposits from the limestone. Moreover, expanded views of the surface shows substantial pitting, growths of calcium carbonate filling in the pits and growing together. The 5K image show a lot of pitting on the surface because limestone causes damage on the surface.
