# Louisville / Jefferson County Hazardous Material Commodity Flow Analysis

*Final Report*

*August 2012*

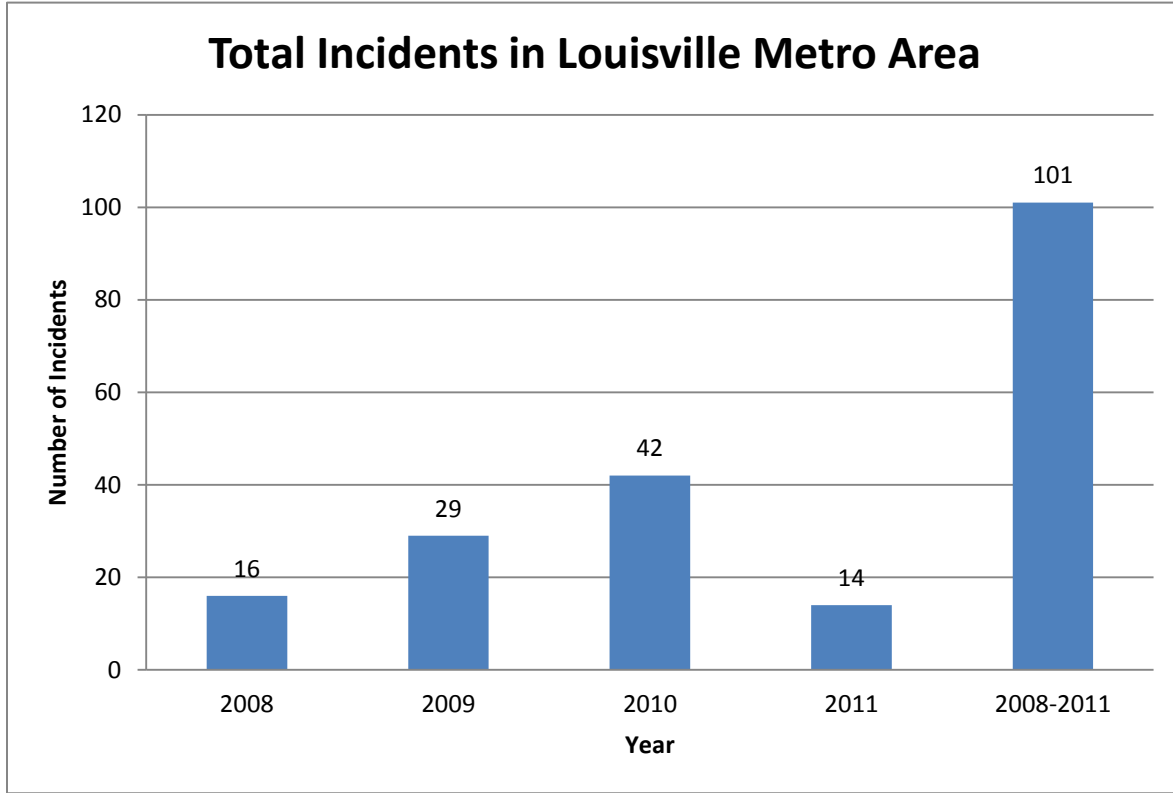
Figure 2.2: Total number of incidents in Louisville Metro Area

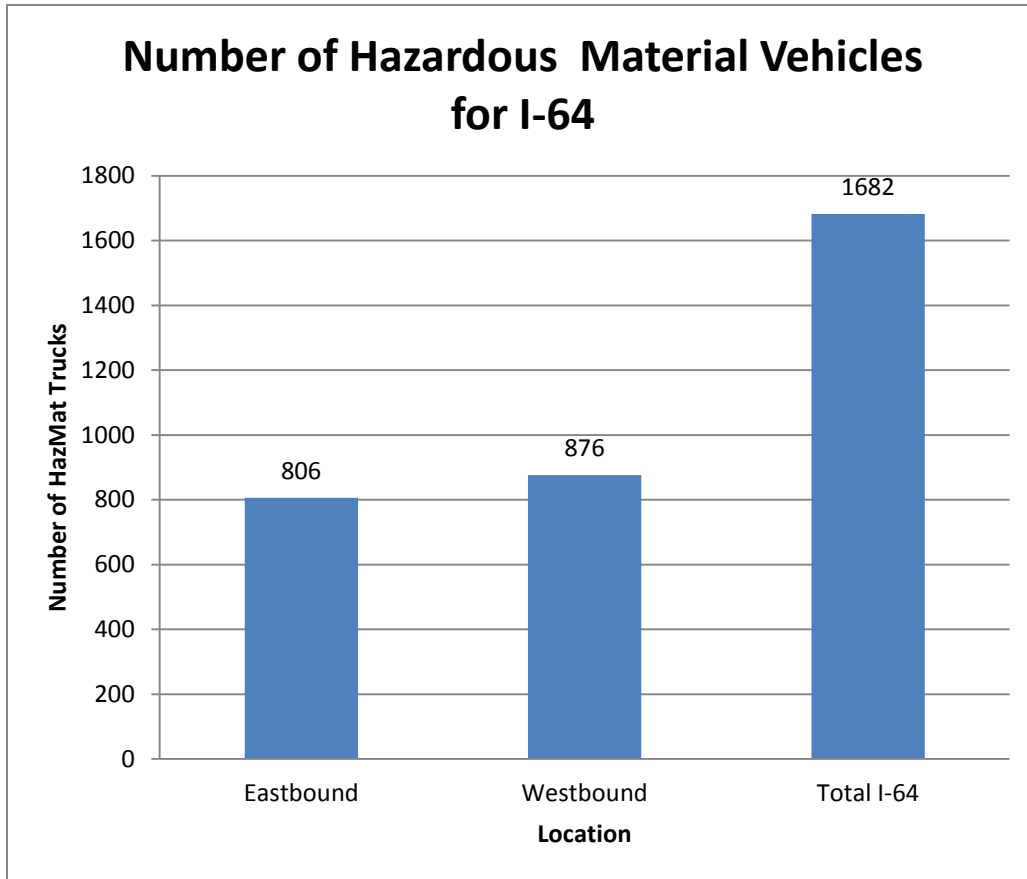
*Figure 3.1: Placarded commercial vehicles observed on I-64*

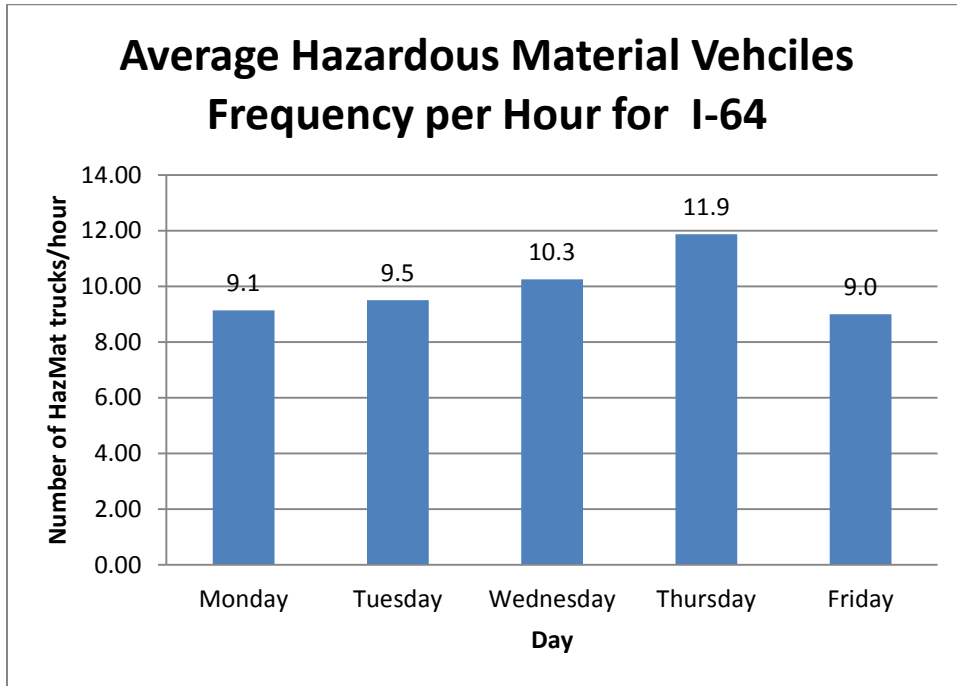
Hazardous material transportation frequency displayed differences throughout the week (Figure 3.2). Total hazardous material transport across I-64 peaked on Thursday, with an average of 11.9 vehicles/ hour. This peak is seen in both eastbound and westbound lanes of traffic (Figure 3.2). The lowest average rate was seen on Friday, with only 9.0 vehicles/ hour.

Figure 3.2: Placarded vehicle frequency per hour by day of the week

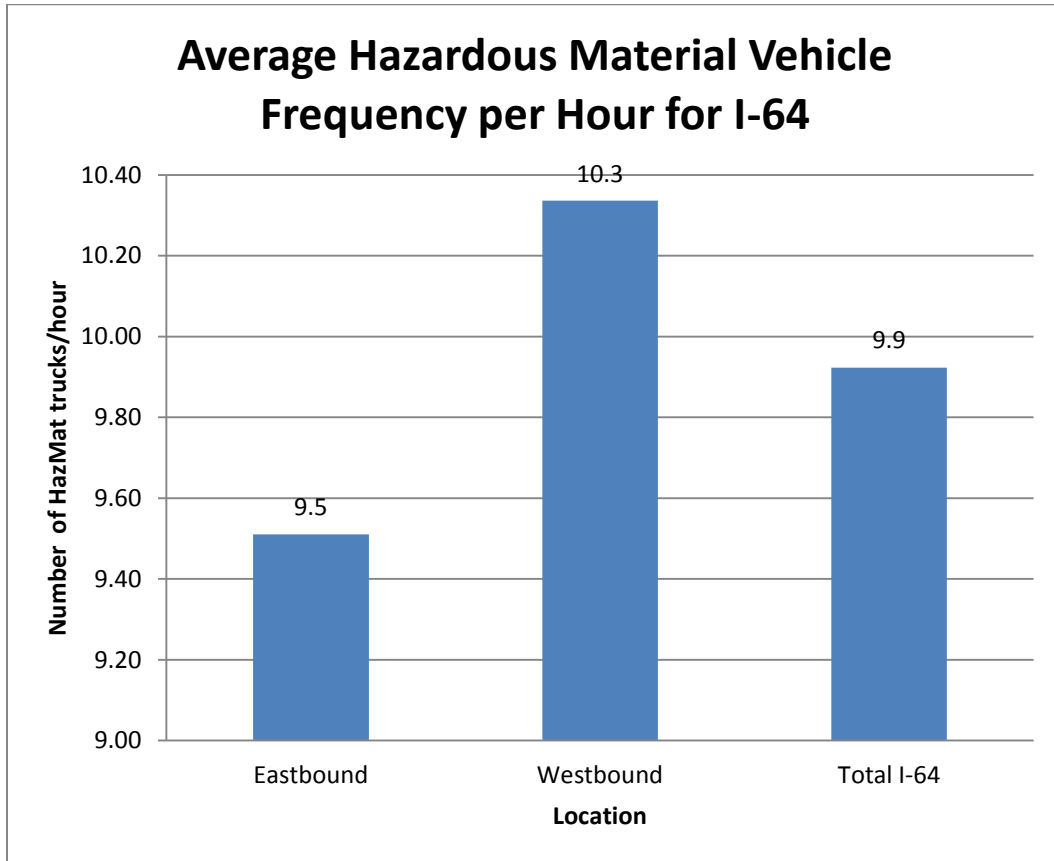
Again, this was also seen in both eastbound and westbound lanes as well. Placarded traffic increased from Monday (9.1 vehicles/hour) to Thursday (11.9 vehicles/hour), prior to the overall low on Friday. Though placarded traffic increased over the course of the week, Monday, Tuesday and Friday exhibited similar traffic (9.1 vehicles/hour, 9.5 vehicles/hour, and 9.0 vehicles/hour, respectively). The average number of placarded vehicles observed, on both eastbound and westbound I-64, was determined to be 9.9 or approximately 10 per hour (Figure 3.3).

Figure 3.3: Placarded vehicle frequency per hour observed on I-64

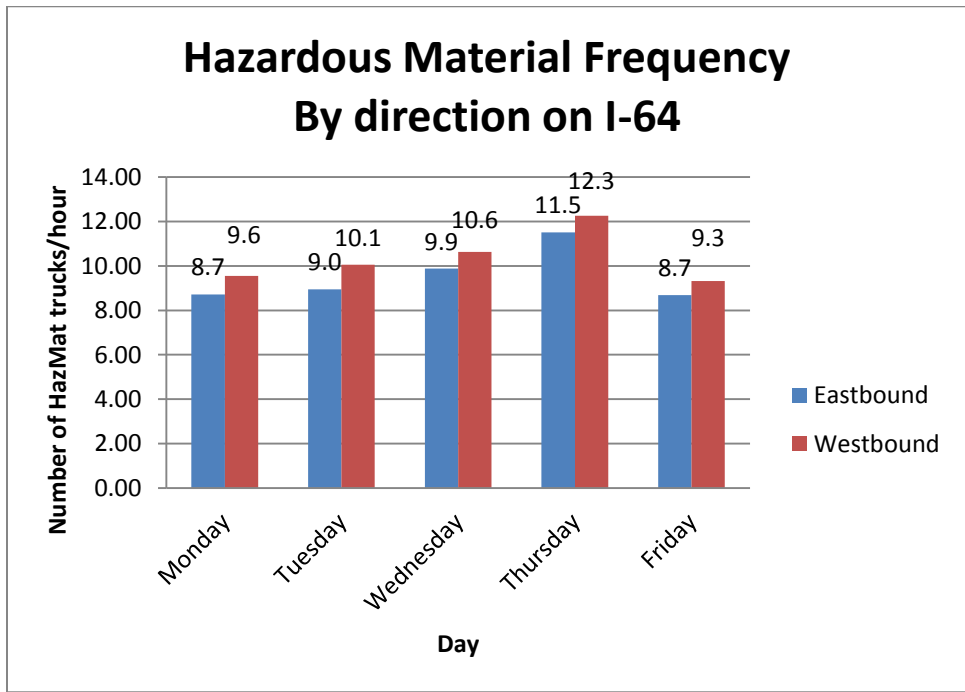
Eastbound and westbound weekly variation is noted in Figure 3.4. As previously noted, peak values were seen on Thursday for both northbound and southbound lanes, while low values were seen on Friday. Much like the overall I-64 trend, both eastbound and westbound traffic increased from Monday to Thursday, with Friday being the weekly minimum value. Eastbound traffic was similar Monday and Tuesday, 8.72 vehicles/hour and 8.95 vehicles/hour, respectively. Westbound traffic was similar Tuesday and Wednesday (10.05 vehicles/hour and 10.63 vehicles/hour, respectively).

Figure 3.4: Placarded vehicle frequency per hour by direction as observed on I-64

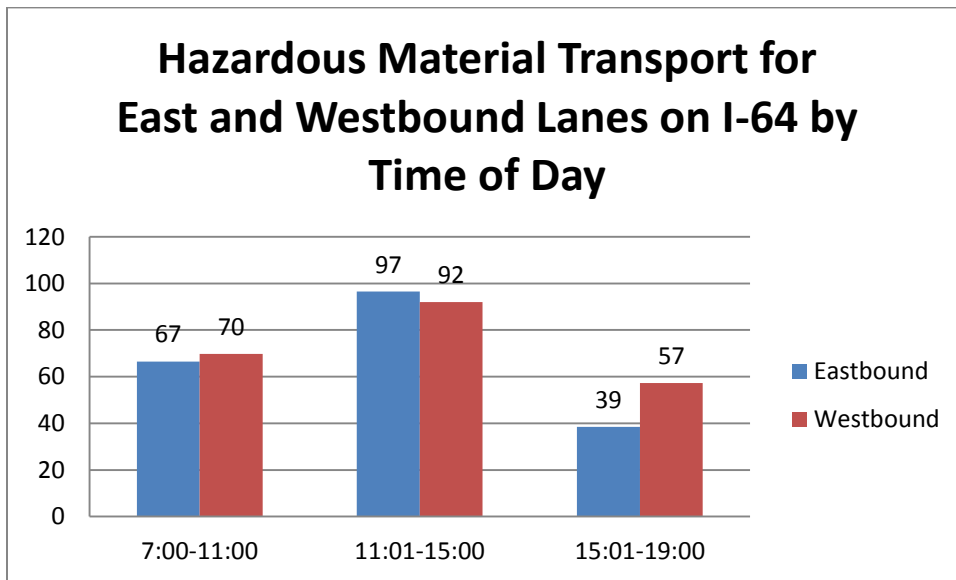
*Figure 3.5: Frequency of Hazardous material by time of the day as observed on I-64*

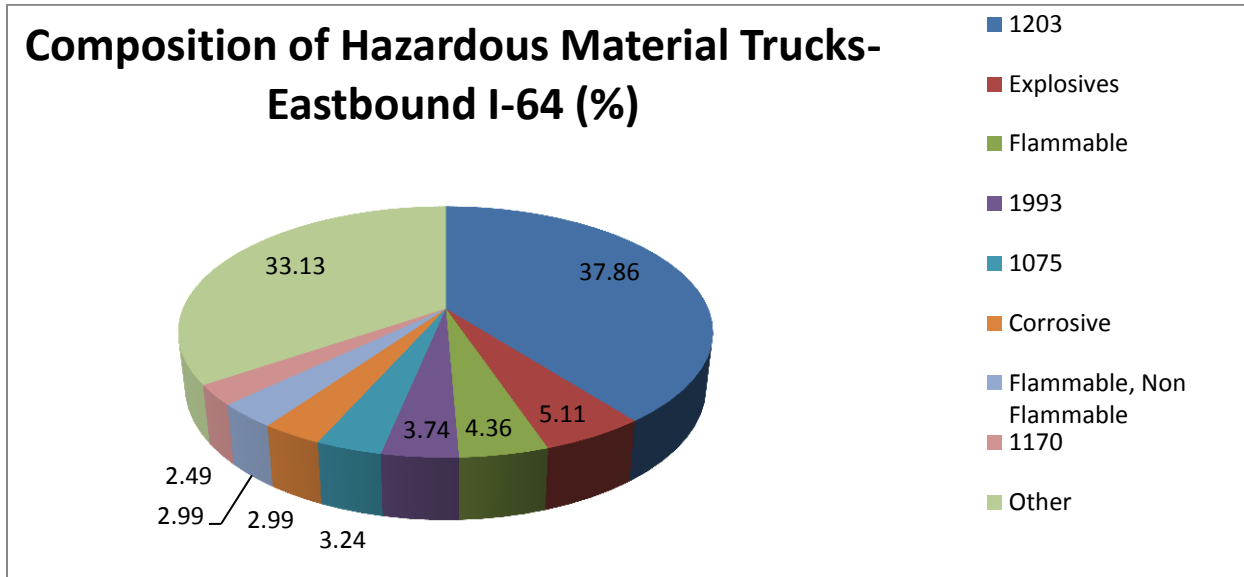
Figure 3.6: Composition of hazardous material being transported on eastbound I-64 by percentage of total load

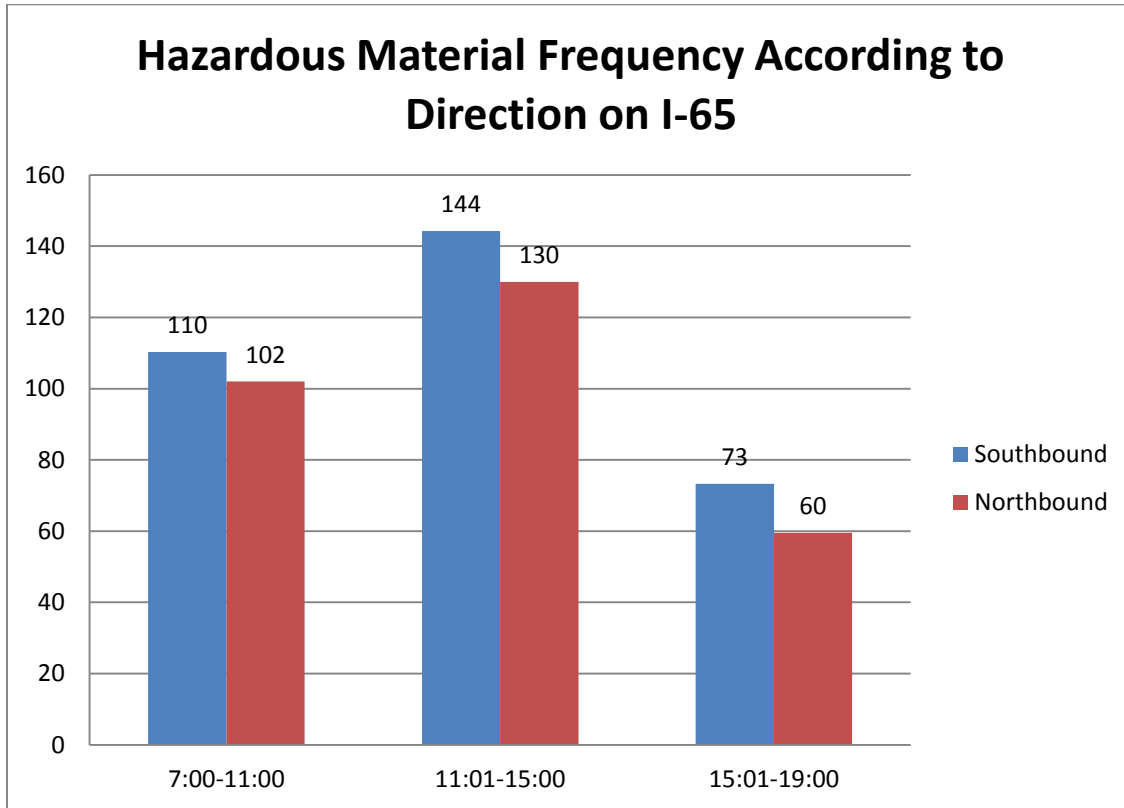
Figure 4.5: Frequency of hazardous material as observed on I-65
