An Investigation of Groundwater Flow in the Vicinity of Patoka Dam, Indiana: Research to Support United States Army Corps of Engineers Dam Safety Risk Assessment

Lee Anne Bledsoe¹, Chris Groves¹, Kenneth Henn² and Jackie Rowe²

¹Crawford Hydrology Laboratory, Western Kentucky University, Bowling Green, Kentucky

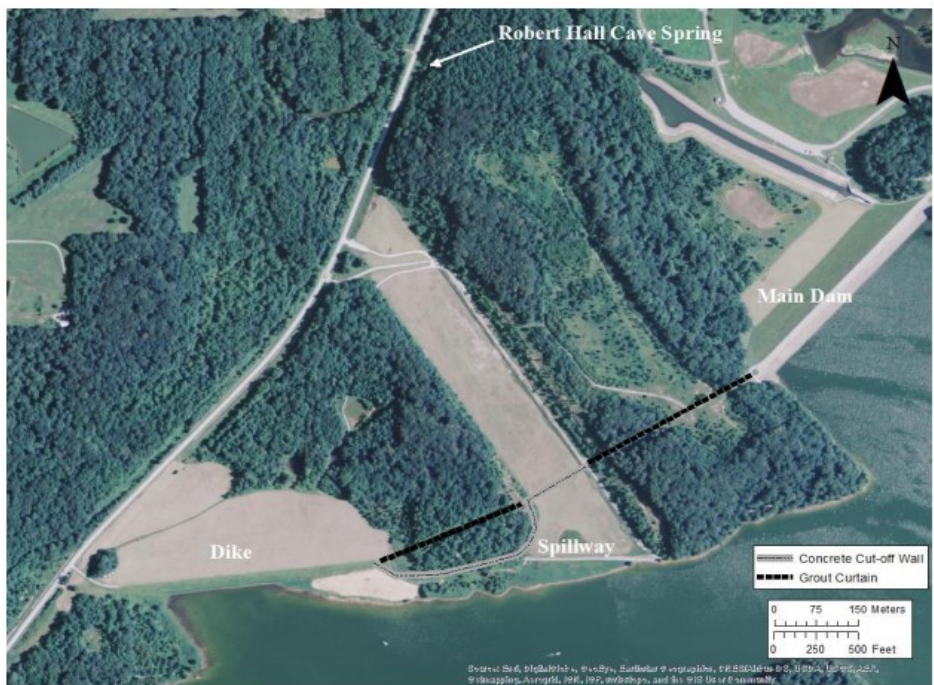
Figure 1. Aerial view of study area

the Glen Dean Limestone, and spring hydrograph analysis was performed to better understand local groundwater hydrology in the vicinity of the existing water control structures that include the dam, grout curtain, dike, and concrete cut-off wall (Figure 1). The previous 2008 risk analysis identified potential failure modes, one of which was abutment seepage and piping failure of the dike and therefore efforts were focused in this area. Results identified the general local flow direction as south to north and indicate that a limited amount of groundwater is bypassing the control structures in the vicinity of the cut-off wall (Figure 2). Groundwater travel times within the Glen Dean Lime-
